VOLVO OCEAN RACE - SAIL DAMAGE REPORT

DATE	07/04/2015
TEAM	TEAM SCA
REPORT MADE BY	Nathan Quirk – Head of Boatyard Sail loft
SAIL	FRO-R
DATE AND LEG DAMAGE SUSTAINED	Leg 5 Volvo Ocean Race
CONDITION (1 (unusable) - 10 (new))	1 – Unusable

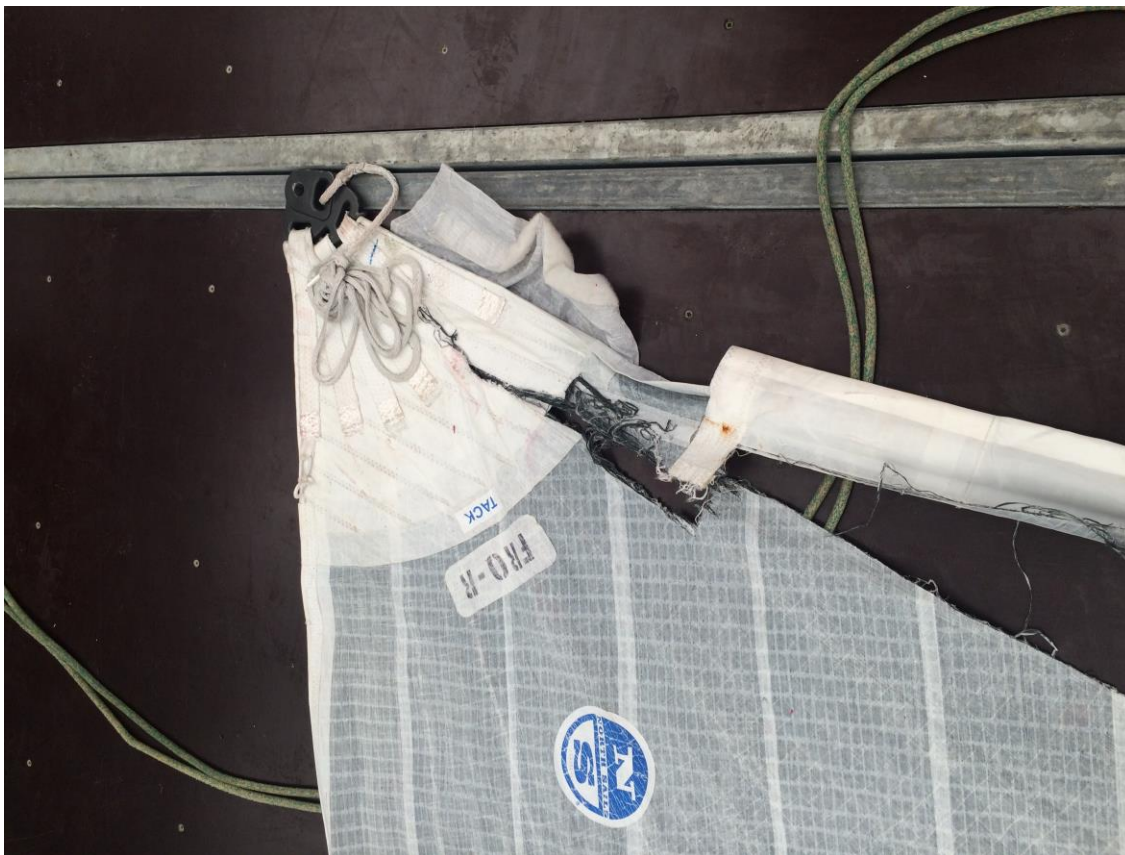
REINFORCED TACK SECTION

The FRO-R has sustained major damage which extends vertically up the sail behind the luff tape from inside the reinforced tack area to a point 2.5m below the top ¼ stripe. From there the break continues horizontally across the sail to the leech. The leech tape and line are both broken.

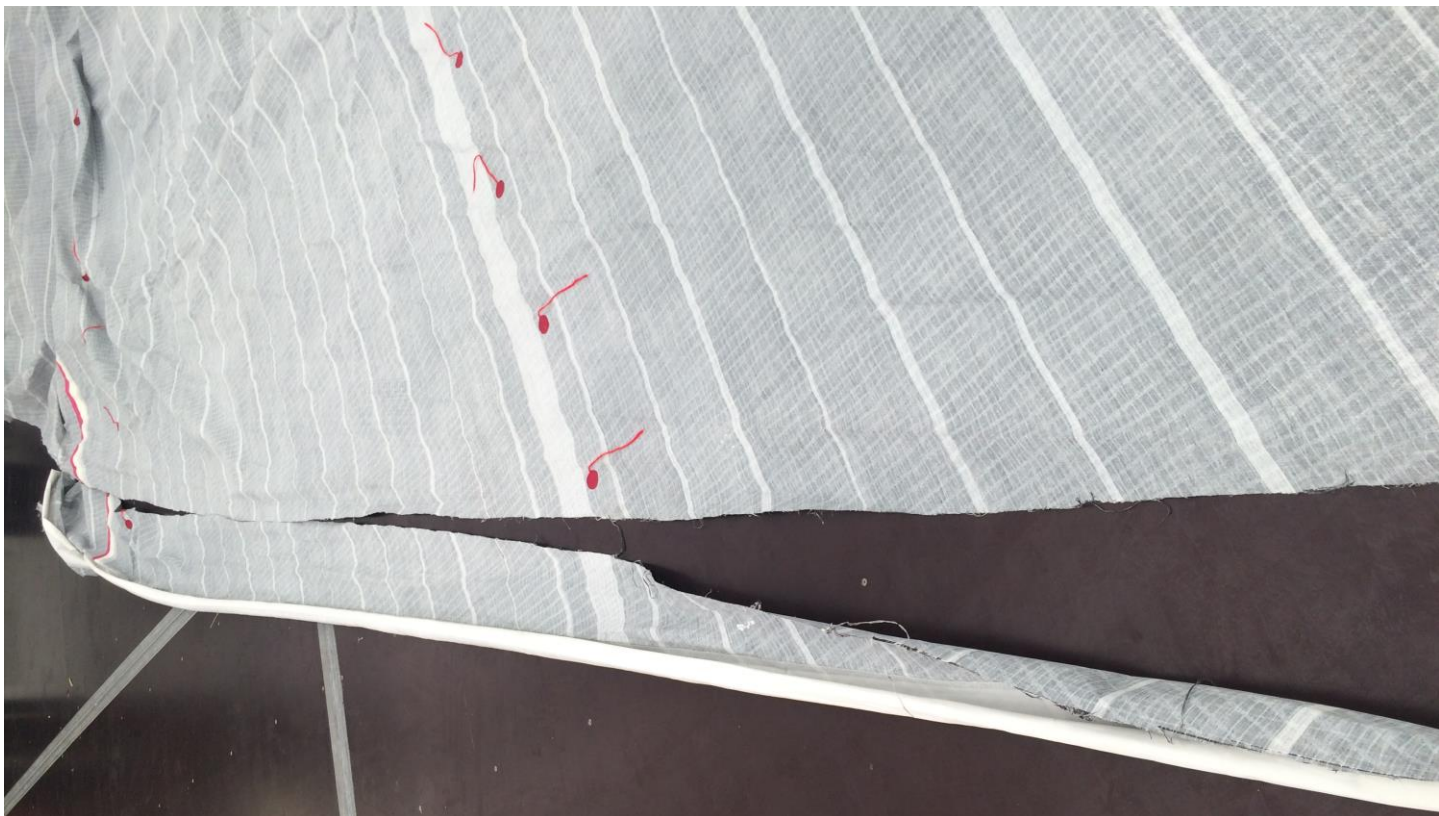
LOOK UP SAIL FROM TACK

The break is not clean and the cloth has been severely damaged up either side of the tear. In places up the luff the tear and damage to cloth extends up to 800mm aft into the sail.

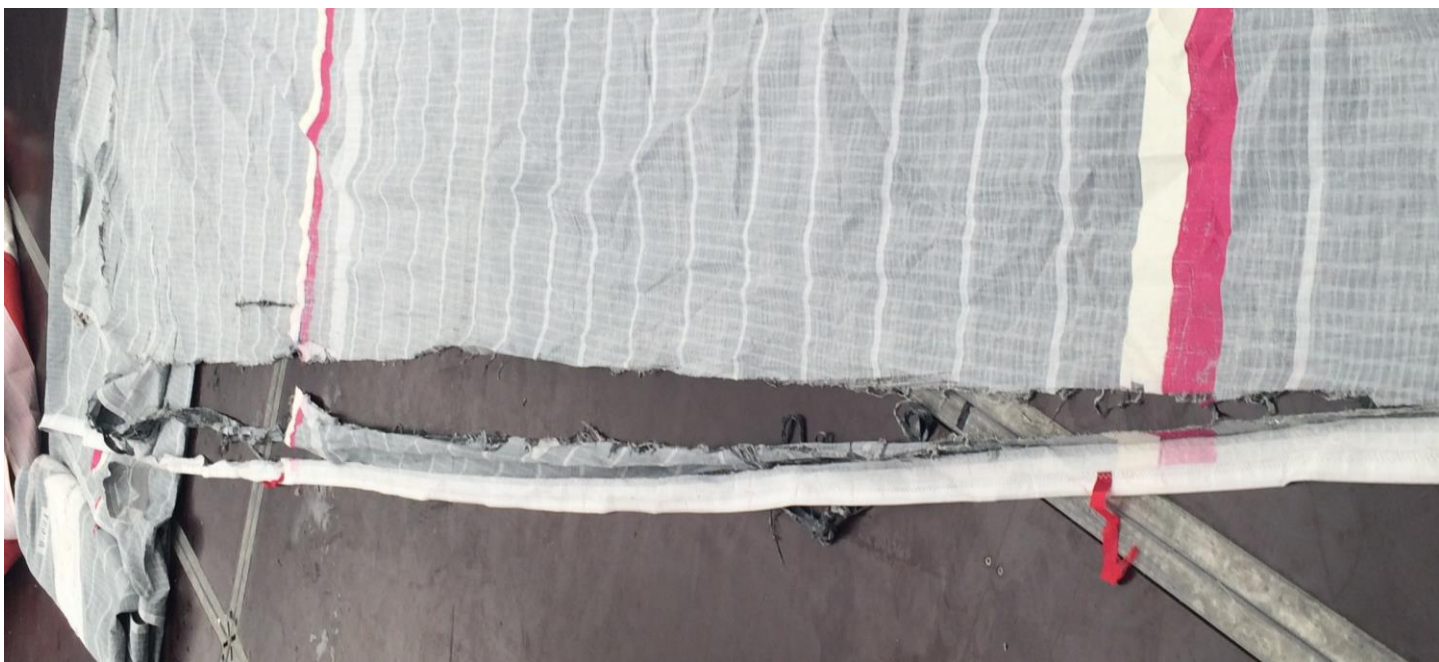
LOOKING DOWN LEECH FROM HEAD

The top section was subject to severe flogging until it could be retrieved and as result the cloth is badly damaged to a point where its structural integrity is questionable.

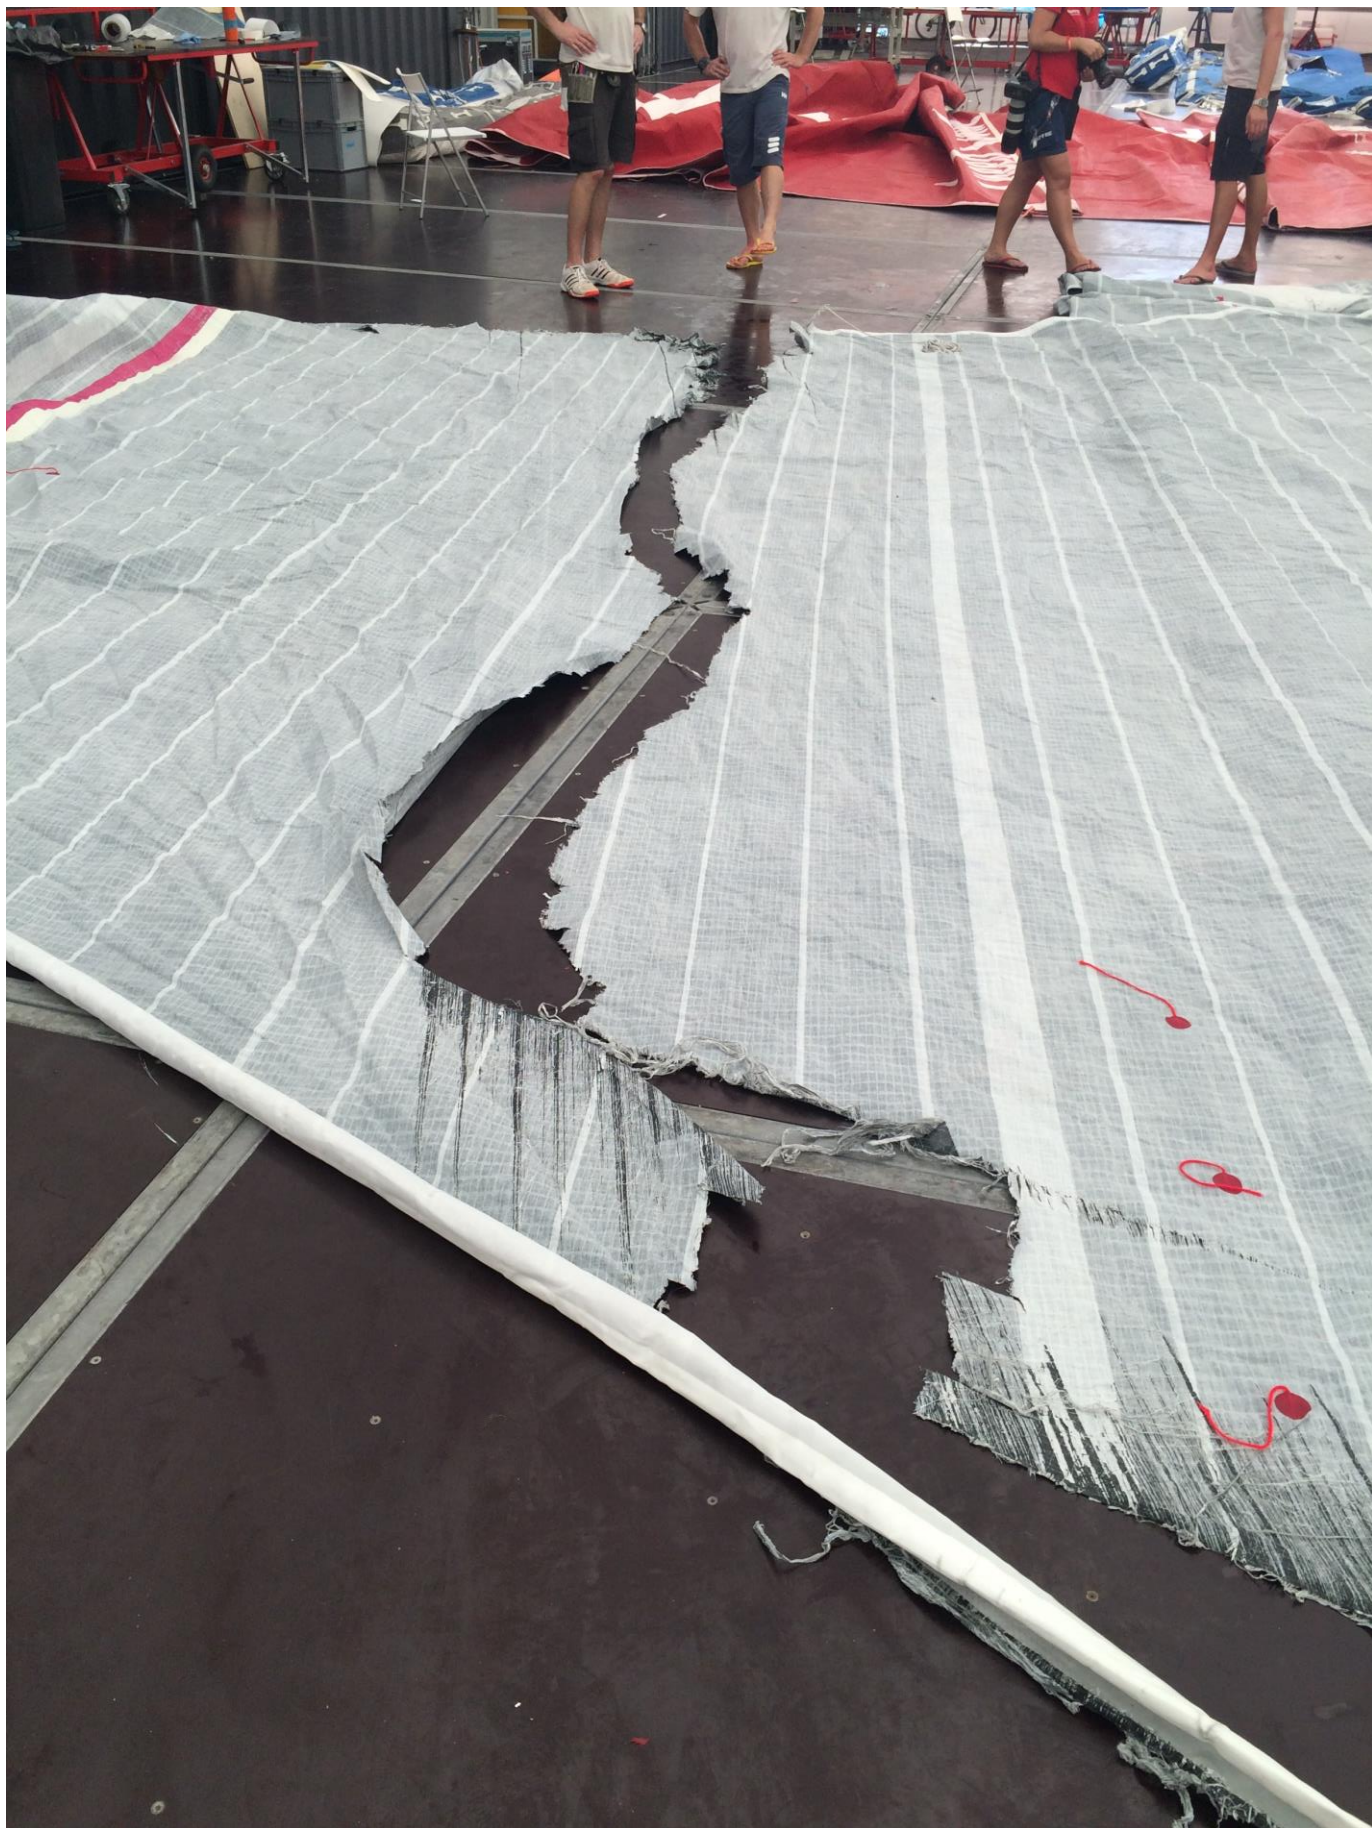
HORIZONTAL BREAK 2.5m BELOW $\frac{3}{4}$ STRIPE

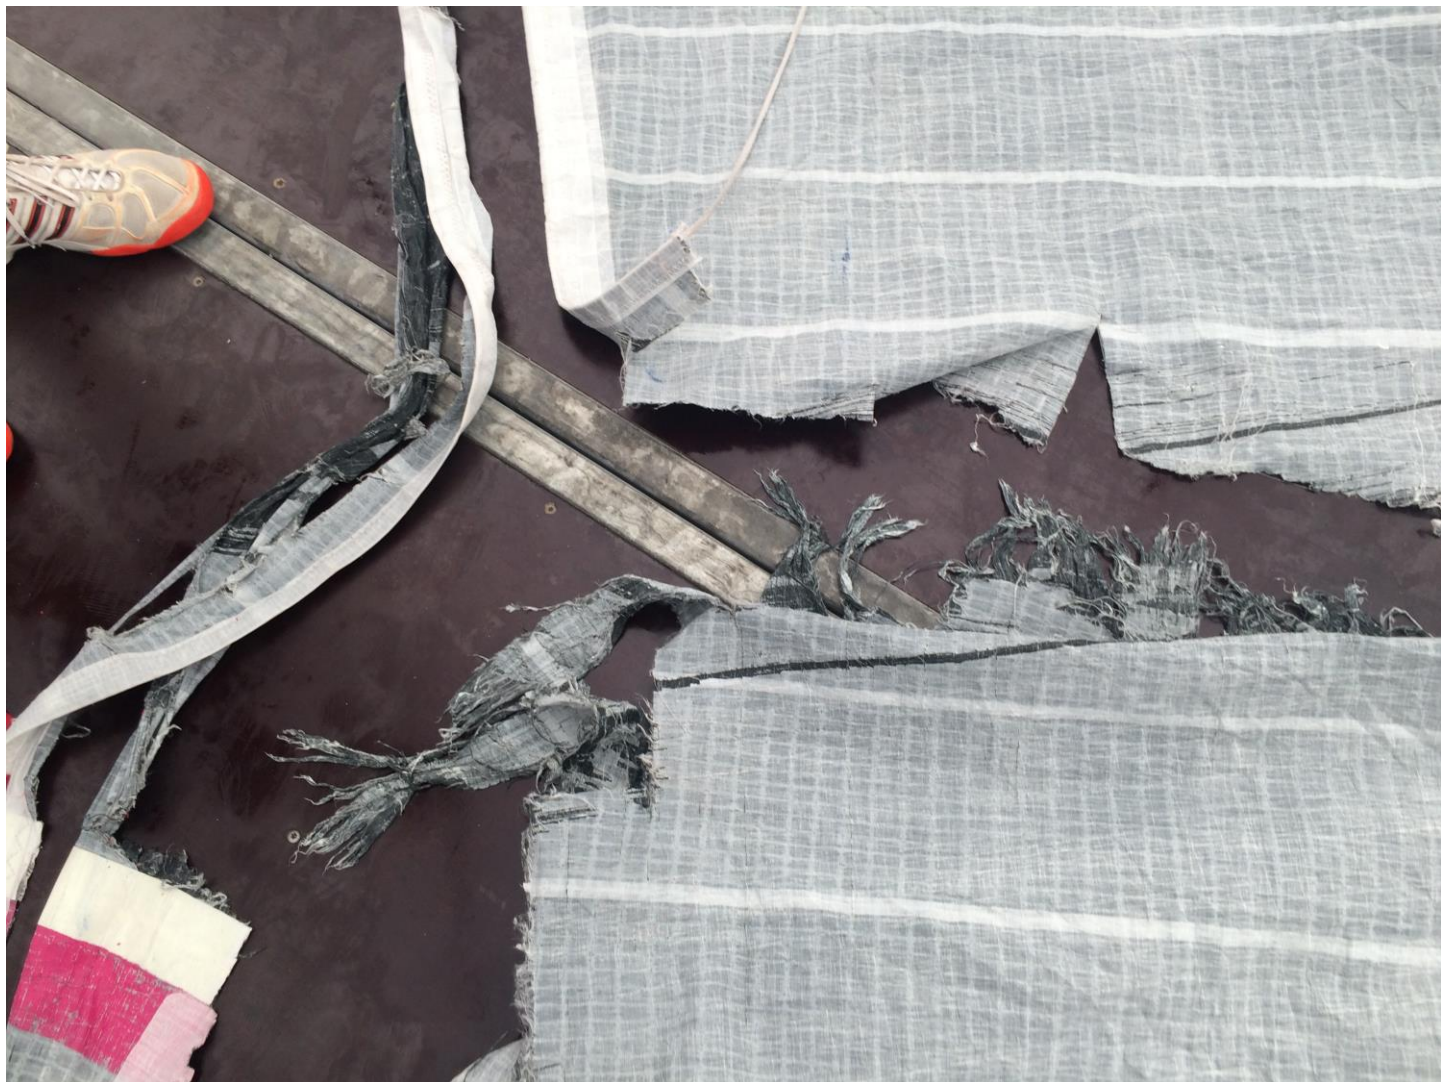
LEECH END OF HORIZONTAL BREAK
